Manhole Inspection Summary

Manhole # S31UU1007MH

Insp Date: **3/19/07 11:47 AM**

Location Address: **124 HOMELAND AVE**

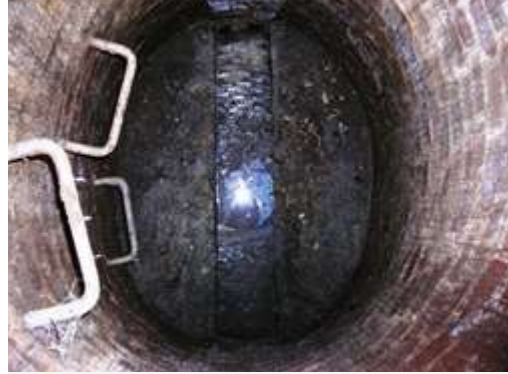
Top View

Evidence of surcharge - Bench debris.
Channel debris.

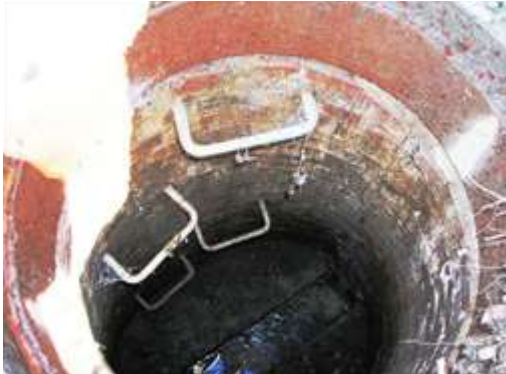
Defect

Frame leaks. Frame offset. Adjustment,
Corbel and Barrel infiltration - other side.

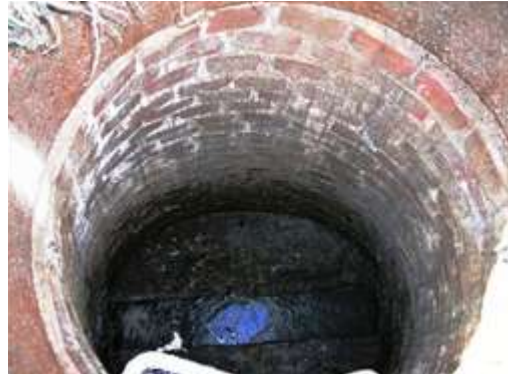
Defect

Frame leaks. Adjustment, Corbel and
Barrel infiltration.

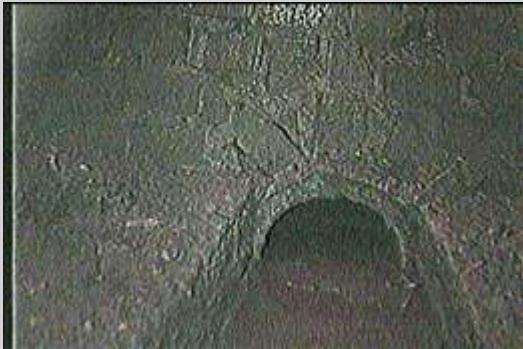
8 in. Circular Gravity Sewer Pipe Out @ 12 O'Clock

Infiltration: **None** Pipe Seal Cond: **Cracked**

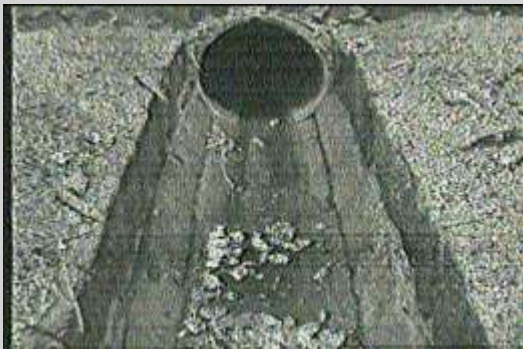
8 in. Circular Gravity Sewer Pipe In @ 6 O'Clock

Channel deterioration.
